Goodworth Clatford and Upper Clatford Conservation Area

Character Appraisal

2 The Goodworth Clatford and Upper Clatford Conservation Area

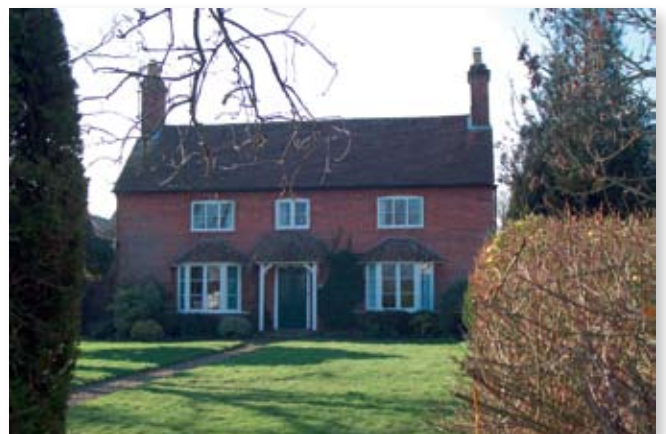
The scattered listed buildings along this part of the north-south road through the village help to form a narrow intimate streetscene, as they are built close to the road frontage on both sides of the street. The Lawns (Grade II) is probably the most significant listed building within this part of the conservation area and dates from the early 19th century. It is constructed of brick and tile, with flint banding on the end elevation to the side road, and has a symmetrical front, bay windows to the ground floor and a tiled canopy on posts to the doorway. This building is set back some considerable distance from the main road and has a substantial northern boundary brick wall to the Barrow Hill road.

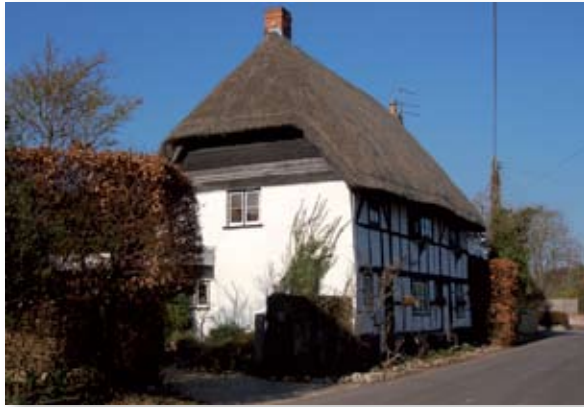
Queen Anne Cottages (Grade II) is particularly notable for its timber-framed construction with projecting oriel windows and its prominent position on the roadside, which, along with the adjacent white rendered and thatched 'The Cottage' (Grade II), provides the termination for views through several parts of the streetscene – looking both north and south.

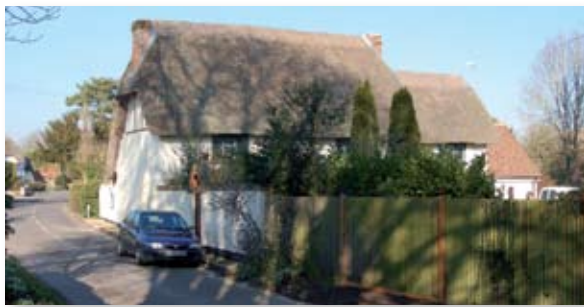
Goodworth Clatford Cottage (Grade II) is built at right angles to the roadway and dates from the 18th century with later extensions. It is typical of many of the listed buildings within the village, and includes rendered walls, with some exposed timber framing and a massive thatched roof.

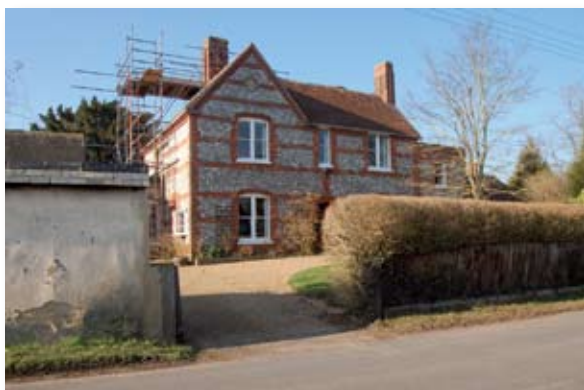
Flint House has been identified as a building of local interest and is particularly prominent within the streetscene. It is a substantial dwelling built of brick dating from 1871, and is a more imposing building than the surrounding small historic cottages and complements The Lawns (Grade II), adjacent. It is set back from the road within a large garden and is a substantial two storey house of flintwork with red brick banding and corner detailing and has a clay tiled roof. This imposing building includes a series of traditional outbuildings and

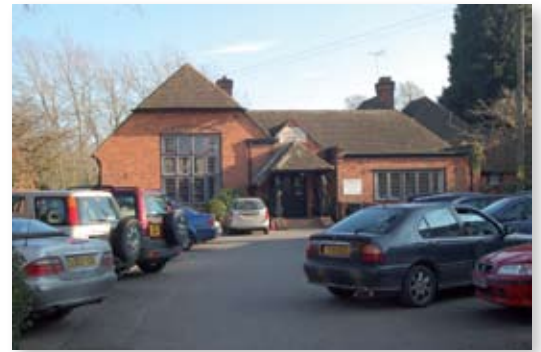
The Village Club on the eastern side of the road was built in 1923 at the expense of Sir Alfred Yarrow (the marine engineer and shipbuilder who lived nearby at Green Meadow). The hall, built in the Arts and Crafts style of brick with tile creasing and hipped roofs, includes distinctive leaded light windows with mullions and transoms and has a rustic wooden porch. The hall includes a billiard room, sports pavilion and adjoining caretaker's cottage. It has been identified as a building of local interest.

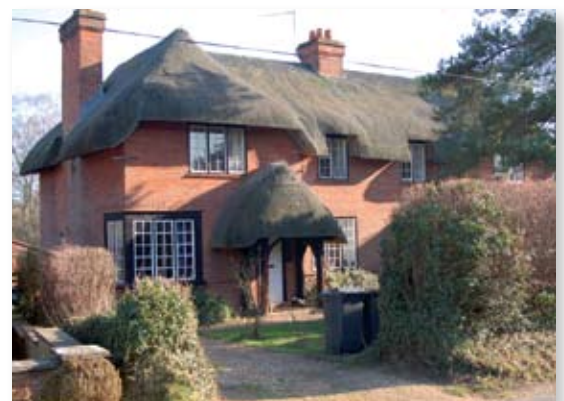
Nos 1 and 2 Lavender Cottages

The other buildings of local interest also contribute to the homogeneity of this historic streetscene, representing simpler 19th century cottages located between the listed buildings. These non-listed buildings generally complement the adjacent historic buildings, through the use of traditional materials and detailing, including such as the use of thatch (at nos. 1 and 2 Lavender Cottages).

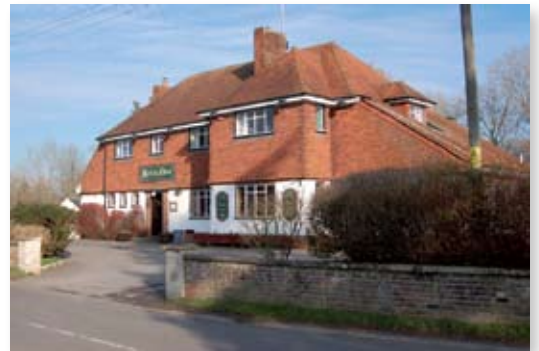
There are no listed buildings in this character area, but two buildings of local interest have been identified – The Royal Oak Pub and Olde Rose Cottage. The Royal Oak Pub is not particularly outstanding in its architectural form and detailing, however it does reflect local materials, with the use of clay tiles, rendered walls and relatively steeply pitched roof with a catslide detail. This building is more important in the wider streetscene as it forms the termination of views through the conservation area north and south through the main village street and also forms the gateway into this part of the village after crossing the River on Church Lane.

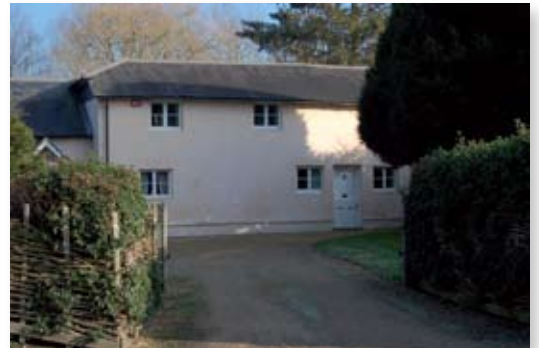
Olde Rose Cottage appears to be a cob building of earlier origins than most of the buildings within the area. It is typically rendered, and has relatively small window openings with deep reveals, set away from the corners of the buildings. The dwelling is mainly concealed behind a mature hedge, with only glimpsed views gained from the main road through the village.

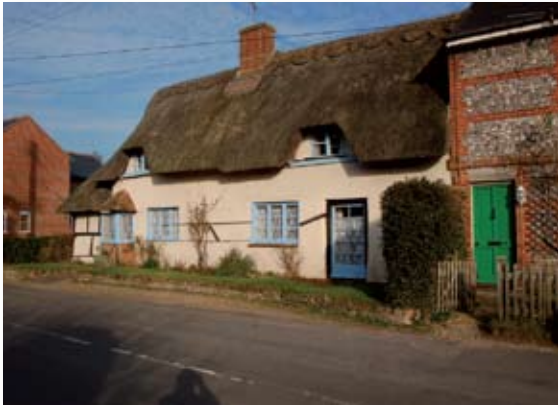
Old Cottage

The four listed buildings are all modest historic cottage type buildings, which are a feature of this village. Old Cottage, The Thatchings, Yew Tree Cottage and Goodworth Cottage represent the traditional local materials and architectural detailing prevalent within this part of the Test Valley Borough, demonstrating timber framing, rendering, brick and flint, and massive thatched roofs. Small traditional timber or metal casement windows are prevalent, as are the doors which are generally simple timber ledged and braced, and often include small thatched porches over.

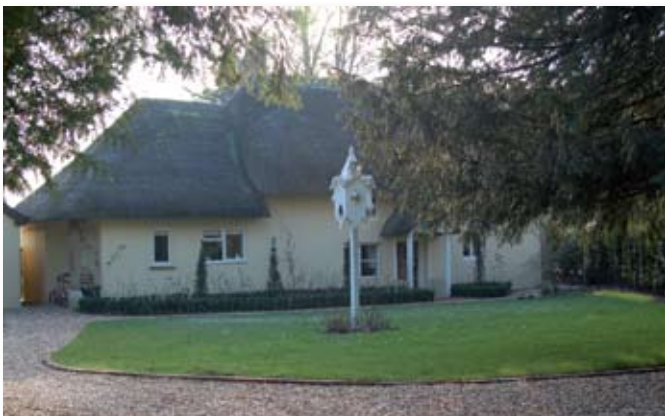
There is one listed building within this area and two buildings of local interest. Rose Cottage (Grade II listed) is located at right angles to Church Lane and dates from the 18th century (with later additions). It is rendered with a thatched roof over. Opposite Rose Cottage are Fishing Cottage and Rushmoor Cottage, both of which date from the late 19th century. These buildings have been identified as being of local interest as

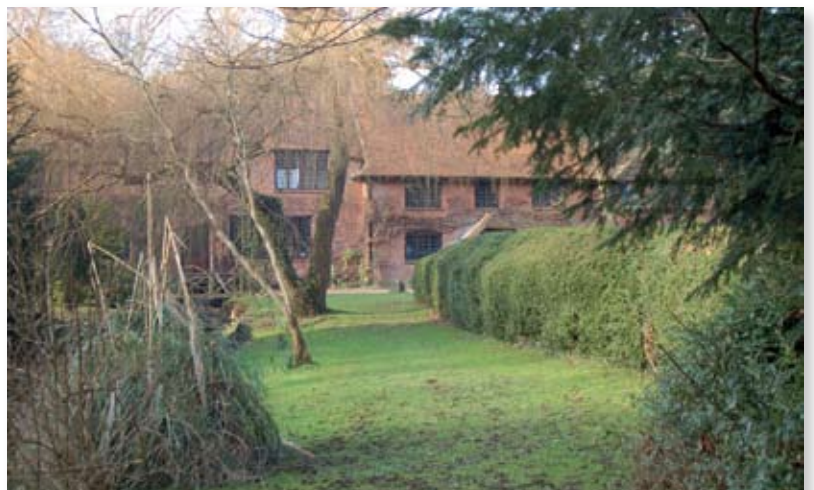
There are two listed buildings within this character area, listed Grade II and three buildings of local interest. Green Meadows was once a corn mill on the river. The 18th century mill and mill house were converted in 1921 to a single dwelling for Sir Alfred Yarrow (see the reference above to the Village Club) by the architects Davis & Emanuel and Henry Smart. A further wing was added in 1922. The current house is a picturesque brick and tile structure with leaded casement windows. The mill section was originally thatched with reed and there is an 18th century four bay timber-framed and brick thatched building (recently rebuilt following a fire). There is a 19th century granary adjacent with a hipped tiled roof and boarded walls which sits on staddle stones (both are listed Grade II). The house is only visible in glimpses between mature trees and hedgerows from the adjacent Green Meadows Lane but nevertheless makes an important contribution to the character of this part of the conservation area.

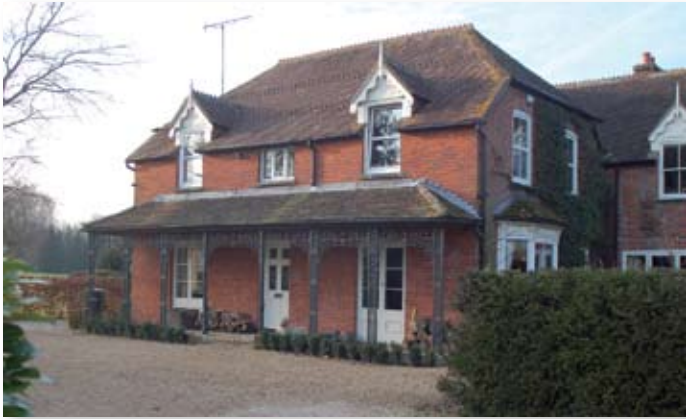
The adjacent Meadow Lodge to the north is a late 19th century dwelling. What is particularly special about this building is the survival of decorative architectural detailing from the period, including a cast iron veranda to the front of the building.

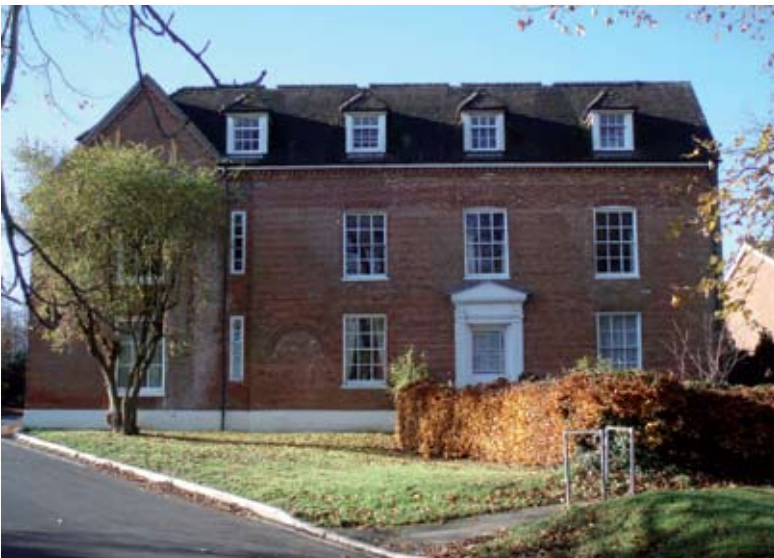
Clatford Manor House (Grade II) is a mid 18th century dwelling which has now been converted into flats. This is an imposing building in a prominent position on the edge of Clatford Green and is viewed through the avenue of trees lining Red Rice Road. The building is constructed of brick and tile and is notable

for the quality of its detailing, including fine brickwork, timber vertically sliding sash windows and doorcase with pediment, cornice, frieze and pilasters.

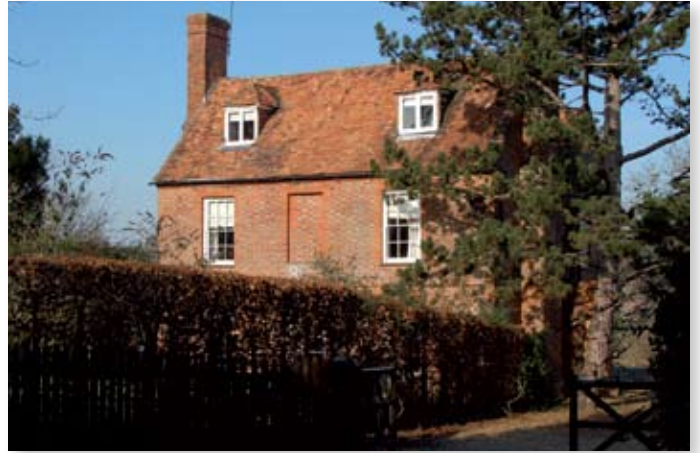
Bury Hill Farm House

Bury Hill House (Grade II) is an 18th century property located in a prominent position within the streetscene on a corner of the main road through the village and visible as a termination of views northeast through the Clatford Green area. The House is constructed of brick, including blue headers with red brick dressings which include quoins (corner details) and cambered rubbed brick arches to the ground floor window openings. This is another significant building within this small village, reflecting the historic relationship of Upper Clatford and the importance of agriculture in the development of the settlement.

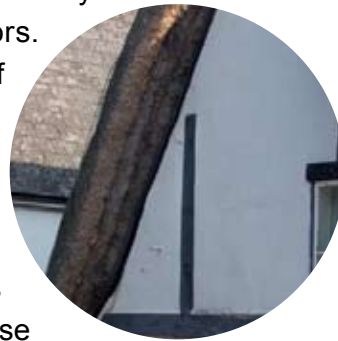
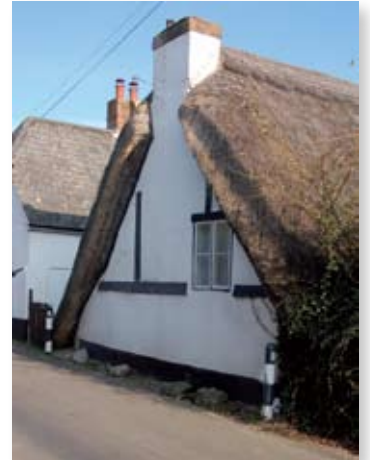
Layer of thatch,
Reed Cottage

An important characteristic of many of these older vernacular cottages is the fact that the end elevations generally abut the road, as demonstrated by Reed Cottage, Hope Cottage, The Old Forge, The Old Post Office, Lovells Cottages and Garden Cottage. These cottages generally date from the 17th century or very early 18th century and are constructed of building materials traditional to this area, including timber-framing, cob, brick walling and massive thatched roofs. Reed Cottage has perhaps the most spectacular of these roofs, with historic layers of thatch visible and the roof touching the road.

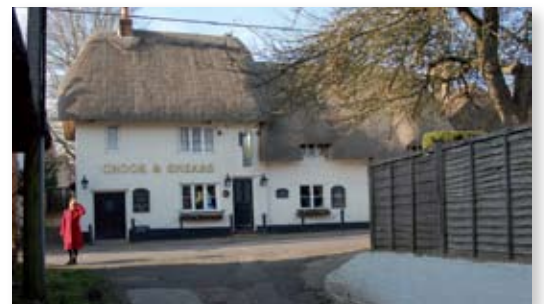
The Crook and Shears Public House

The Crook & Shears Public House (Grade II) is a substantial thatched building. It is the only pub within the village and is prominent within the streetscene, especially in views west along the historic track leading towards the valley bottom, which today serves several residential properties. Unlike the smaller cottages, this building faces the road and has a substantial presence within this part of the village.

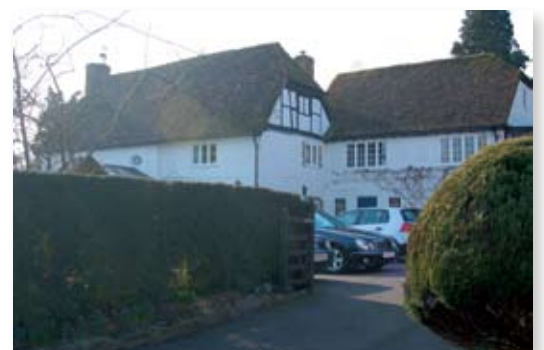
Berwick House (Grade II) is a larger 18th century dwelling which is more imposing than the earlier simple vernacular cottages on the village street. The house is unusually set within a garden area, away from the road frontage. It is constructed of flint and brick (now painted) with some small areas of timber framing visible at the gables. Pounceys Cottages (Grade II) are constructed of brick and flint - a historic building material characteristic of this part of Hampshire. These materials are particularly striking in views through the village particularly when they have been left unpainted.

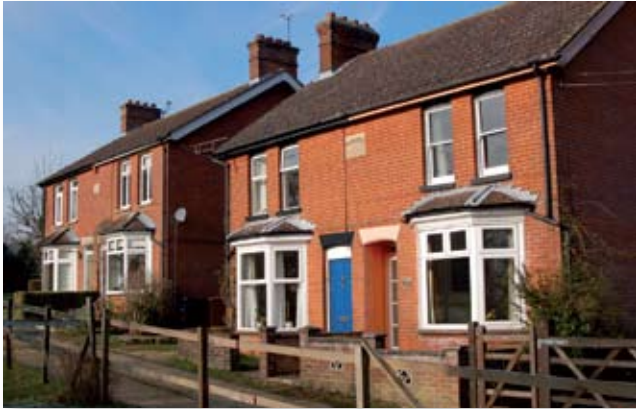
Sunnyside and
Mount Villas

Anchor View, Lee View, Sunnyside, Mount Villas & Hill View are all non listed buildings of local interest which represent the late 19th and early 20th century development within the village. These buildings are typical of the period, being semi-detached brick workers' cottages. These buildings retain some original features, such as timber vertically sliding sash windows and traditionally detailed doors and boundary treatments. However, erosion of this

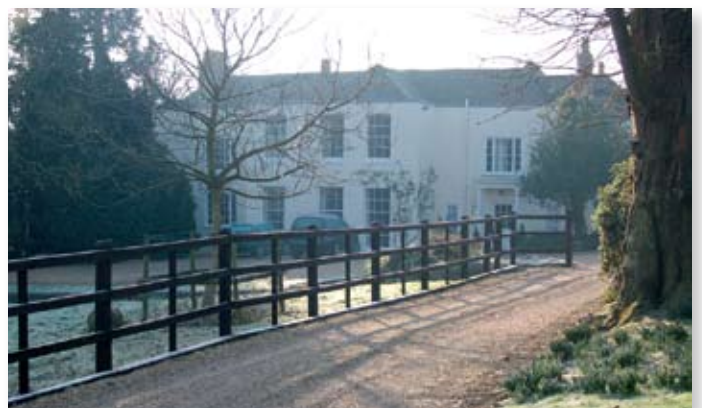
The Old Rectory (Grade II) is an 18th century house with later alterations. It has a stucco (rendered) front with a tiled roof. The front ‘north’ elevation, dates from the 19th century and the centrepiece has a substantial projection and a lower western element. The windows are particularly fine with triple vertically sliding sash units each side of the centre and tall ground floor windows. Adjacent to the rectory is a narrow early 19th century stable block (Grade II), constructed of brick and tile and which backs on to the road. This building, together with boundary brick wall and a substantial cob garden wall returning along the southern boundary of the site enclose the garden to the south of the main house.

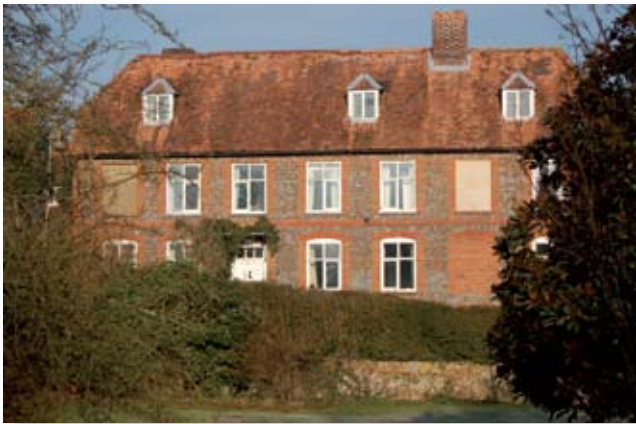
Sackville Court (Grade II) dates from the early 18th century and is constructed of brick walls of blue headers with decorative red brick dressings with a tile roof. This building forms the 'end-stop' to the main linear development on the road through the village. However, this building is concealed from views through the main street and is only visible and prominent in views from the

south on entering the main built up area of the village. Therefore, the setting of this building is enhanced by the open space to the west, rising up the valley side, and the immediate open garden area to the front, enclosed by a brick wall to the roadside and a hedgerow adjoining the large 19th century arched bridge over the dismantled railway and tributary of the River Anton. The eastern boundary is formed by a belt of mature and dense trees and vegetation on the former railway line.

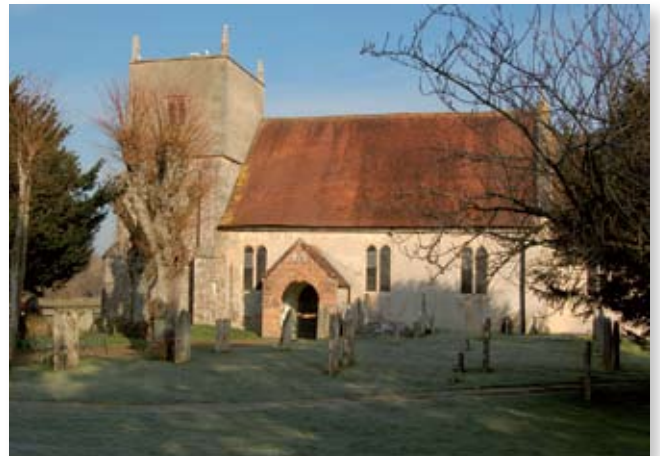
The Church of All Saints dates from the 12th century, with the tower added in 1578 and the porch in the 18th century. The Church underwent significant extension and restoration during the late Victorian period and a modern church room has been added to the north elevation. The building is constructed of flint, with some walls rendered, and has a tiled roof.

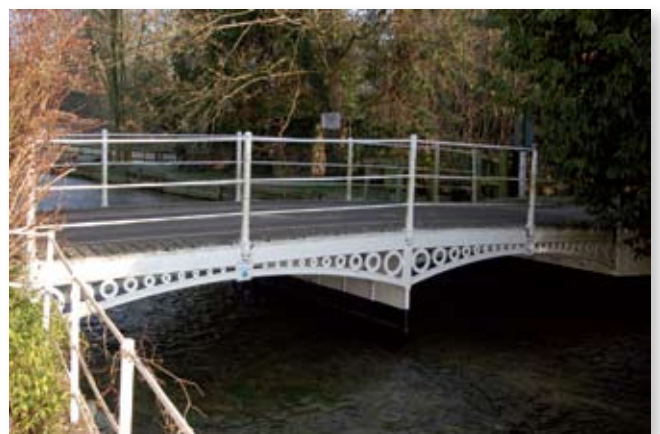
Taskers Bridge

The road bridge over the River Anton is a cast-iron structure made by the local firm of Taskers in 1843 and is listed Grade II. It is a double span bridge formed of arched frames with decorative diminishing circles in the spandrels. The arches rest on cast plates with a panelled decoration. A series of slender moulded columns linked by three horizontal rails form the edges of the bridge. This bridge forms an important social and industrial link to the valley's past and is also prominent in views through the conservation area at this point.

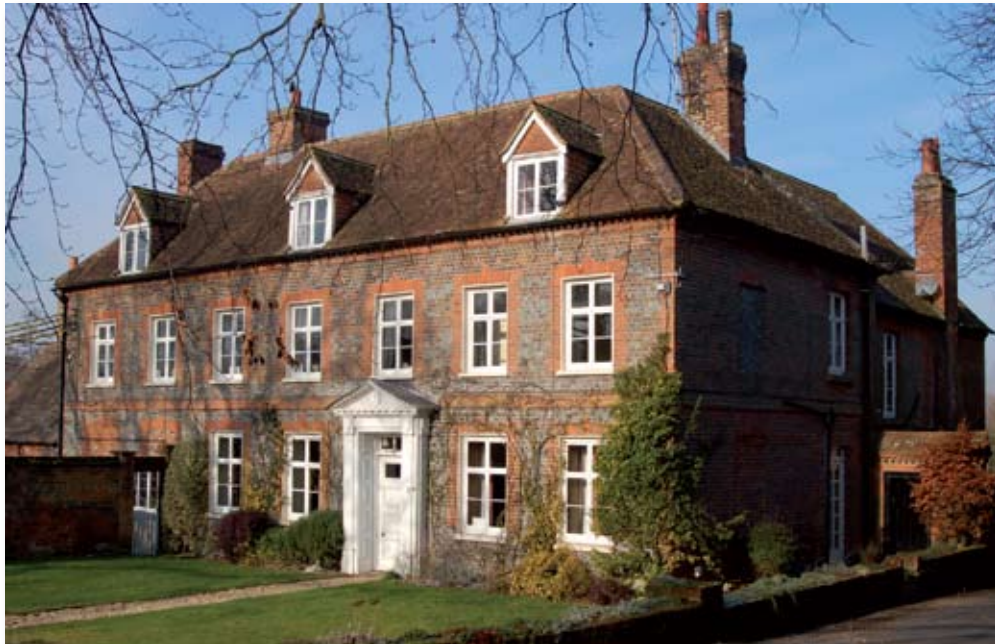
Norman Court Farm House

Norman Court House is an important building dating from the early 18th century and is constructed in brick, with the walls of decorative blue headers with red brick quoins (corner details) and high quality 'rubbed brick' surrounds to the Victorian casement windows. The tiled roof is hipped with a decorative dentilled brick (resembling teeth) course at the eaves. The building has a classical Victorian doorcase, with pediment, pilasters and panelled reveals. The front of the House looks south over the farmyard area and sits at the south-eastern corner of a garden which is enclosed from the road by an extensive high brick wall.

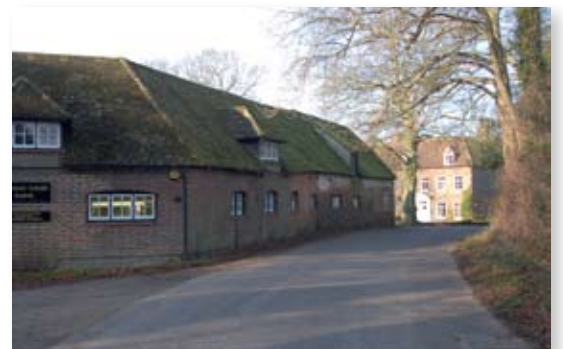
Norman Court barns

The range of barns and stables to the south of Norman Court house, date from the 18th and 19th centuries. It is a continuous range of buildings, with the three 18th century barns adjoined at their ends and arranged in a 'zig-zag' form. The barns include timber framing with brick plinth walls and are weather boarded with a tiled roof. The largest includes six bays, with aisles. The 19th century range of buildings is laid out in three angles in a 'horseshoe' shape, to enclose the courtyard on the eastern side – attached to the 18th century barns at the northern end. These later buildings are constructed of brick, with tiled roofs which have hipped dormers. These farm buildings form an important complex which enhances the historic character of this part of the conservation area and their integrity and modest ancillary character should be retained in the future.

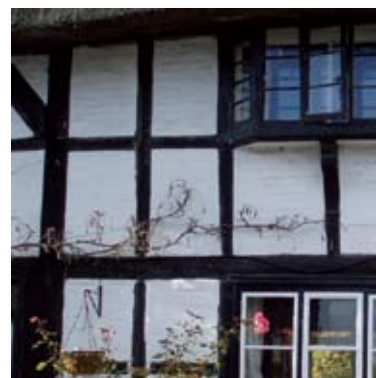
Timber framing,
Queen Anne Cottages

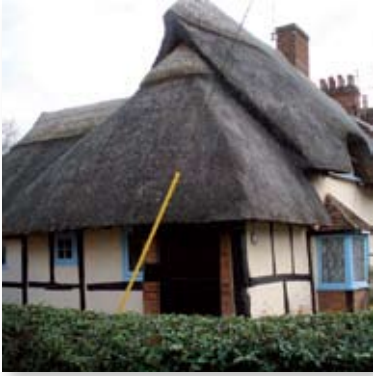
Thatched roof,
Old Cottage

As craftsmen, thatchers take great pride in their work and their individual skills are to be respected. While allowing scope for individuality, it is also important to maintain local distinctiveness if the special character of the area is to be preserved. Historically, thatched roofs in Test Valley have adopted a simple profile with minimum punctuation by dormer windows and other adornment. The appropriate ridge for a long straw roof is termed 'flush' and 'wrap-over' (i.e. sits flush with the main roof slope). Combed wheat reed on the other hand often has a block ridge (one that stands proud) which can be plain or decorated. In the interests of maintaining the simplicity and distinctiveness of the local tradition, the Council encourages the use of flush and wrap-over ridge on both long straw and combed wheat reed roofs.

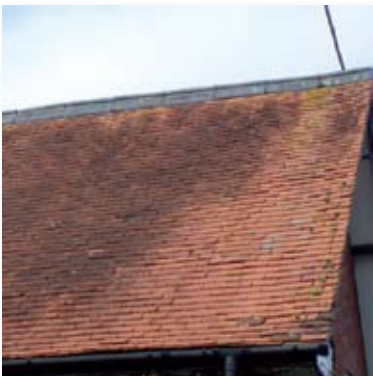
Clay tile roof, Old School

Clay tiles (mainly handmade) were also commonly used in the village, with natural slate used from the 19th century onwards. There is also some later use of concrete tiles. Unfortunately, this material has a much heavier profile than clay tiles and can often appear prominent within the historic streetscene, therefore, its use is discouraged within the conservation area.

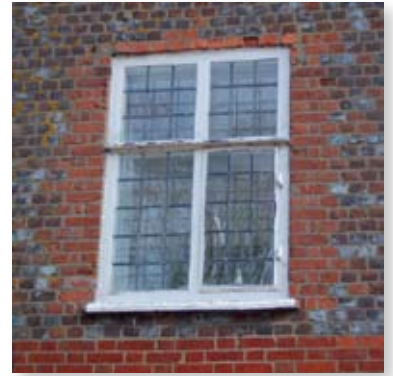
Leaded window, Sackville Court

There are a number of traditional styles of window within the two conservation areas, including timber windows with traditionally glazed leaded lights formed of individual 'quarries' of glass (individual diamond or square pieces of glass) with lead 'comes' (the lead which connects the individual pieces of glass together); and cast iron framed and small paned windows, often with decorative window 'furniture', i.e. catches and window stays. One of the styles found in the conservation area is commonly termed the 'Hampshire casement'. This is a well proportioned single glazed timber window with a single horizontal glazing bar equally dividing the panes.

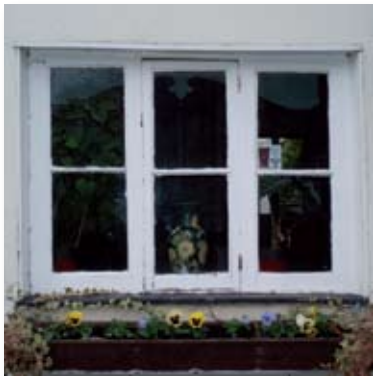
Hampshire casement window,
Crook and Shears Public House

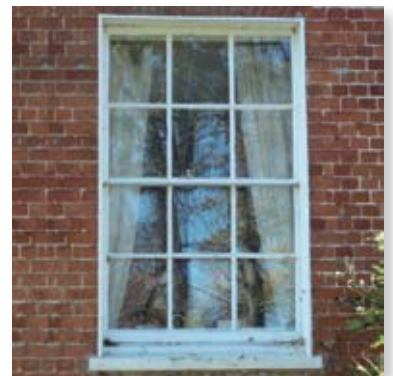
Sash window, Clatford
Manor House

In the grander buildings of the late 18th century or 19th century the prevalent window style for the more significant buildings in the conservation area were, timber vertically sliding sash windows with small panes, which demonstrated the wealth of the owners of the time (for example Bury Hill Farmhouse, Clatford Manor House and The Old Rectory).

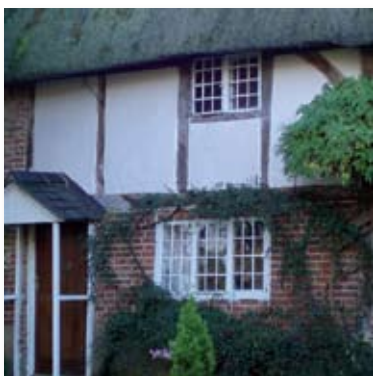
Iron casement windows, Wressle Cottage

Until the beginning of the last century, Upper Clatford was a quiet agricultural community. In 1815, the Waterloo Ironworks was founded nearby in Anna Valley later known as Taskers. These works became a major source of employment for the villagers until its closure in the late 20th century. Products from the iron works are much in evidence in the surrounding area and there are two fine cast iron bridges in the village – Garden Bridge dating from 1840 and the road bridge at Fishing Cottage dating from 1843. Many of the local cast iron casement windows also came from the works.⁹

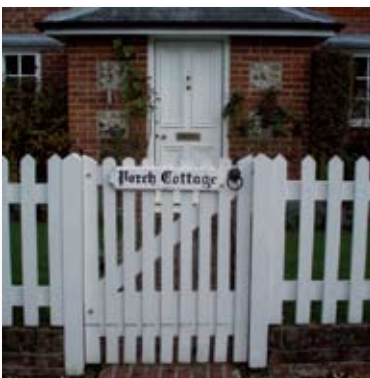
Picket fence and gate,
Porch Cottage

Garden walls, traditionally detailed fences and other means of enclosure such as hedges (discussed later) are important components and make a significant contribution to the character of the villages. Many historic boundaries remain, defining the original plot sizes and are natural or man made.

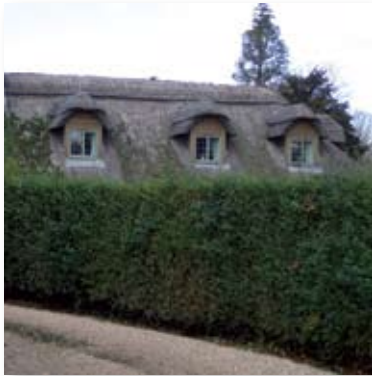
Boundary hedge at The Willows

The predominant boundary feature found around residential properties in both villages and surrounding peripheral agricultural land are hedges. The hedgerows and associated hedgerow trees are particularly important survivals of the agrarian history of the villages and help to retain the verdant nature of the conservation areas, linking the two villages seamlessly to the surrounding countryside.
